INSTALLATION AND SERVICE INSTRUCTIONS

Thames Gas Fired Water Heater

G.C. NO. 52 476 40

NON SPOUTED MULTIPOINT MODEL

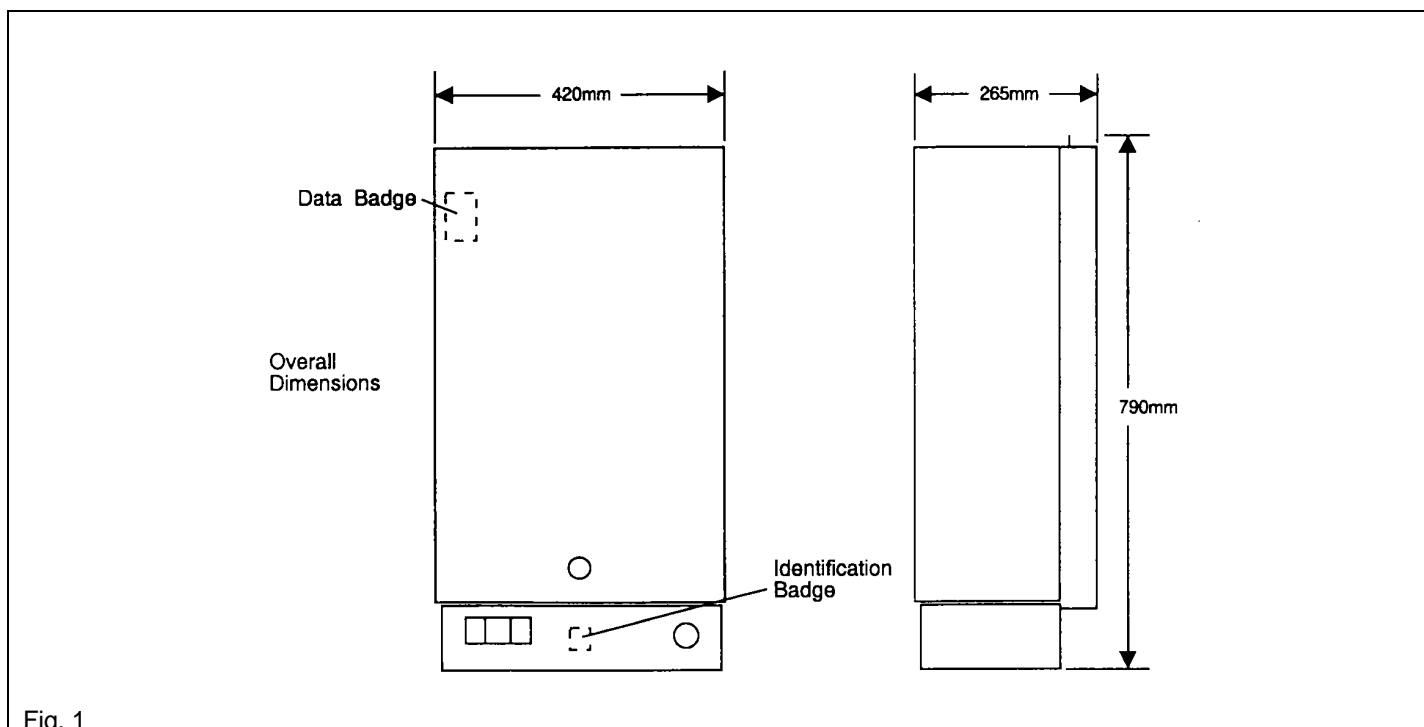
Fig. 1

MINIMUM CLEARANCES

- Above: 60mm
- Below: 75mm
- Sides: 5mm (Each)
- Front: 220mm (To allow for removal of outer case)

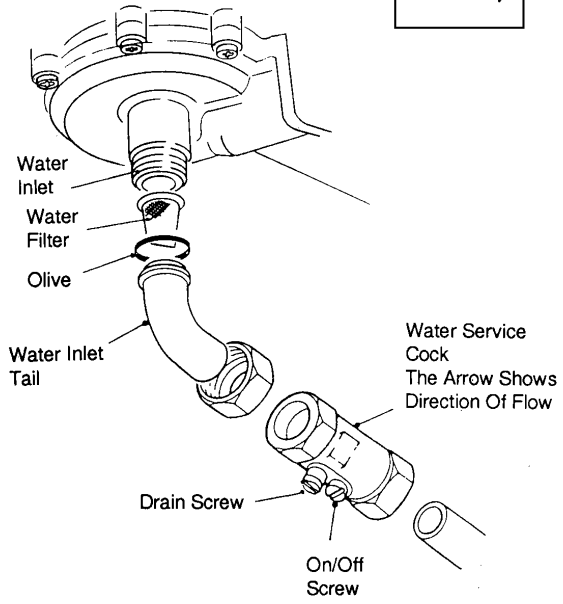
Fig. 7

IMPORTANT
If the water service cock is incorrectly fitted it will not be possible to drain the appliance.

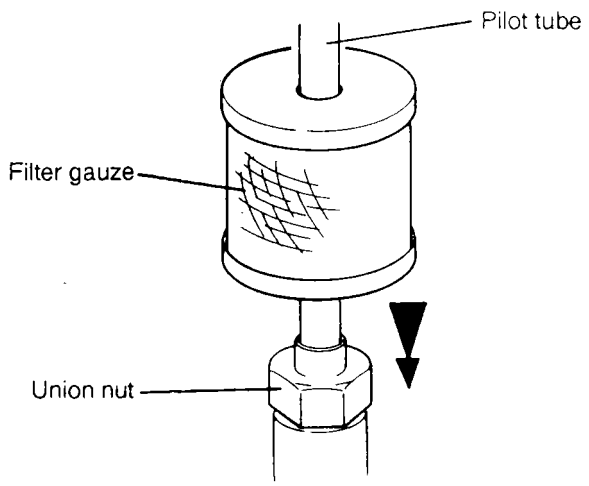
Fig.8

This appliance has a lint filter fitted around the base of the pilot tube.

Ensure that the filter gauze is located inside both end caps and that the complete assembly is correctly seated over the union nut at the base of the pilot tube.

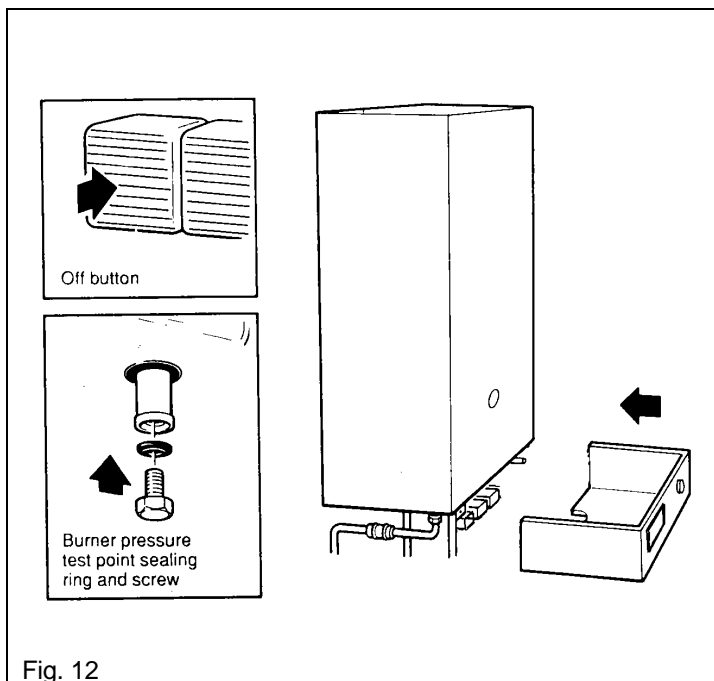
Fig. 12

5. Fully depress and hold the ON button 'ⓘ' and repeatedly press and release the IGN button '⚡' until the pilot is lit. The pilot flame can be observed through the pilot viewing window.
6. Hold the ON button 'ⓘ' in for a further 10 seconds after the pilot is lit, then release. If the pilot goes out, repeat the lighting operation keeping the ON button 'ⓘ' depressed a little longer.
7. Test for gas soundness using a suitable leak detection fluid on all external gas joints.
8. Open a hot water outlet and the burner will ignite. Allow the water to run for a few minutes then check the burner pressure - it should be 12.5 mbar (5 in w.g.), if the pressure is not correct see the FAULT FINDING section.

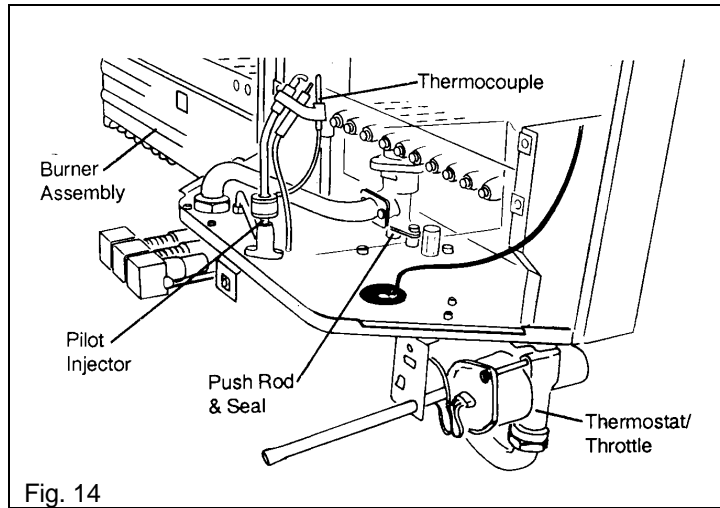
Fig. 14

Operate the appliance noting any faults in the component units. Carry out the servicing procedure then correct any other faults by reference to 'Replacement of Parts', in which section you will find details of how to dismantle and reassemble the following detailed components. Check that the burner ignition is smooth and quiet when a hot tap is opened. The burner ignition has been factory set and should not need adjustment. However, if adjustment is required a slow ignition screw is fitted to the appliance and is situated above the cap screw in the water governor body (fig. 16). Turning the screw clockwise delays the ignition, anti-clockwise advances the ignition.

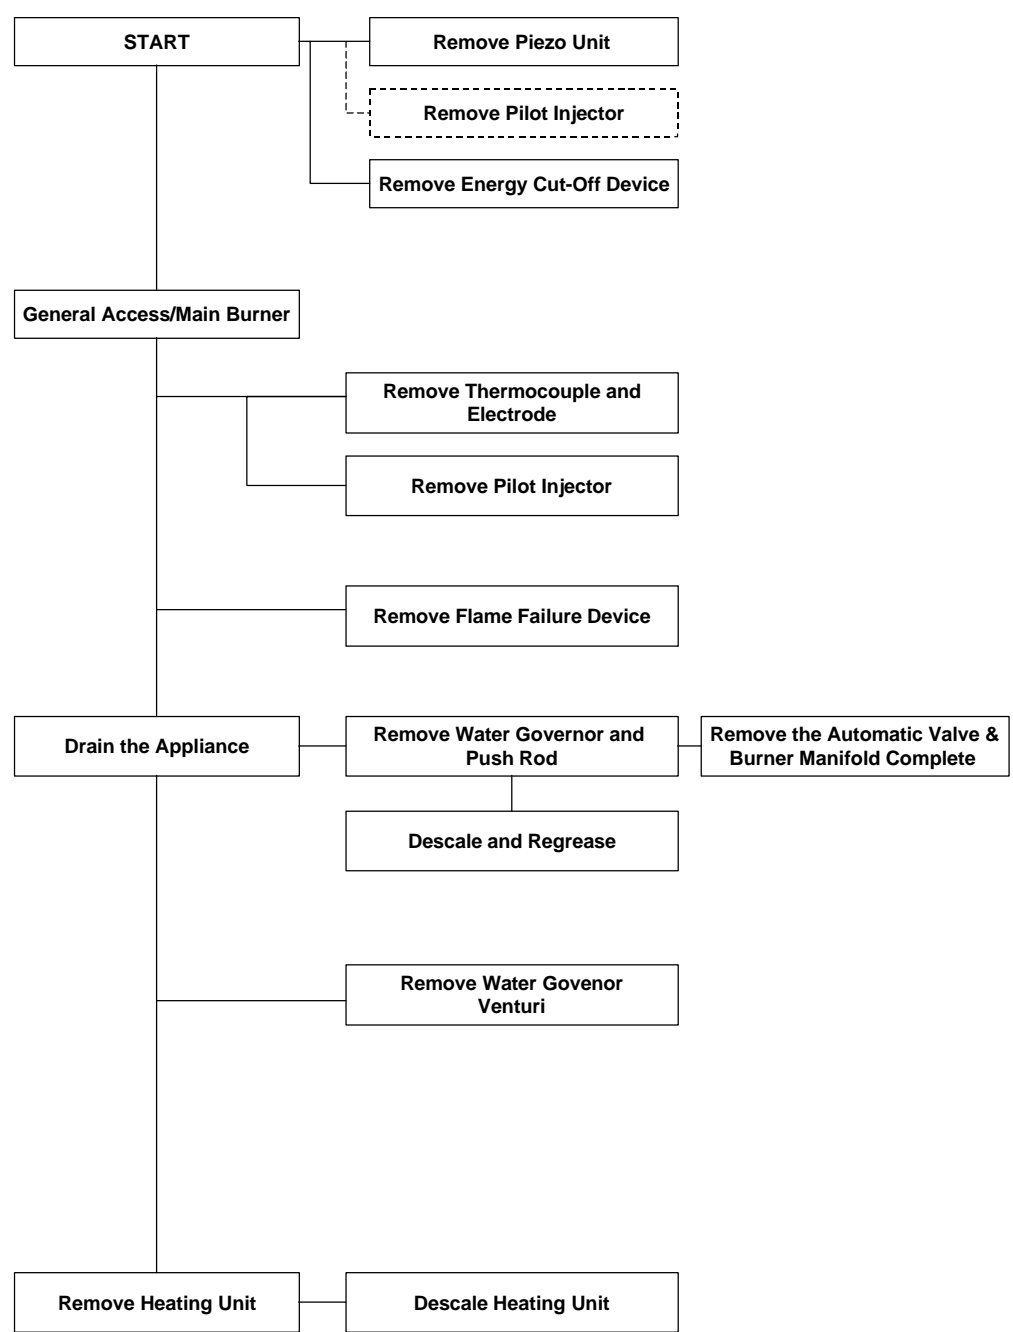
This chart shows the steps to be taken in order access a specific part or perform a particular function. Use this chart in conjunction with the detailed procedures on the following pages.

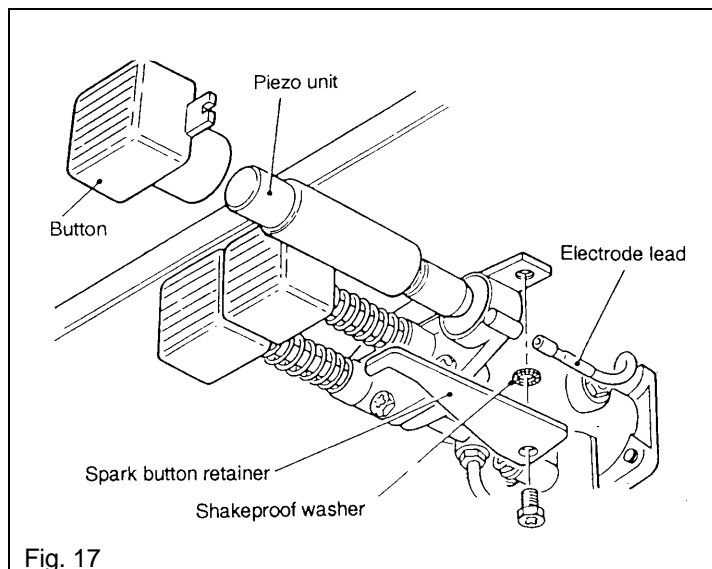
Fig. 17

6.1. PIEZO UNIT

- a. Slide out the bottom cover.
- b. Disengage the electrode lead from the piezo unit.
- c. Remove or loosen and pull aside the spark button retainer, taking care not to lose the shakeproof washer.
- d. Pull off the button and unscrew (anti-clockwise) the piezo from its housing.

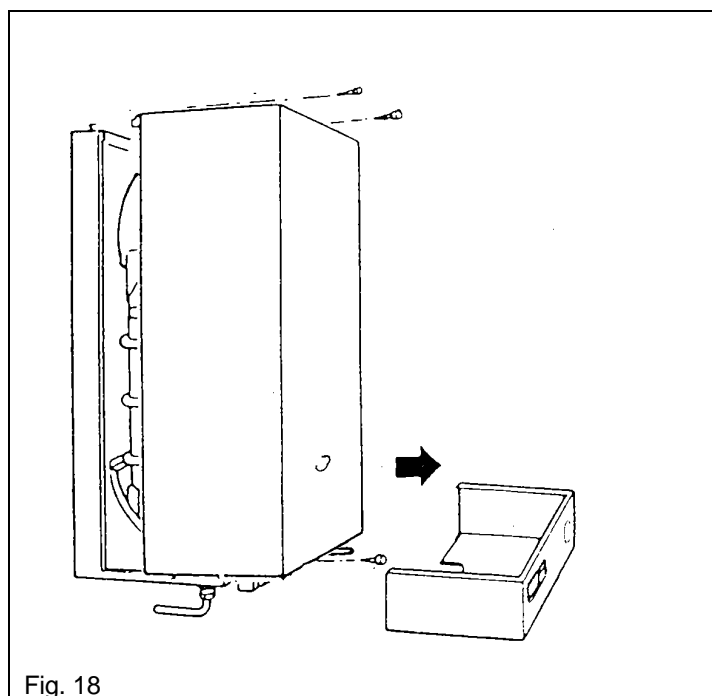
Fig. 18

6.2. GENERAL ACCESS/MAIN BURNER

- a. Turn OFF the gas and water supplies at the service cocks.
- b. Slide out the bottom cover.
- c. Remove the 3 fixing screws and pull off the outer case.

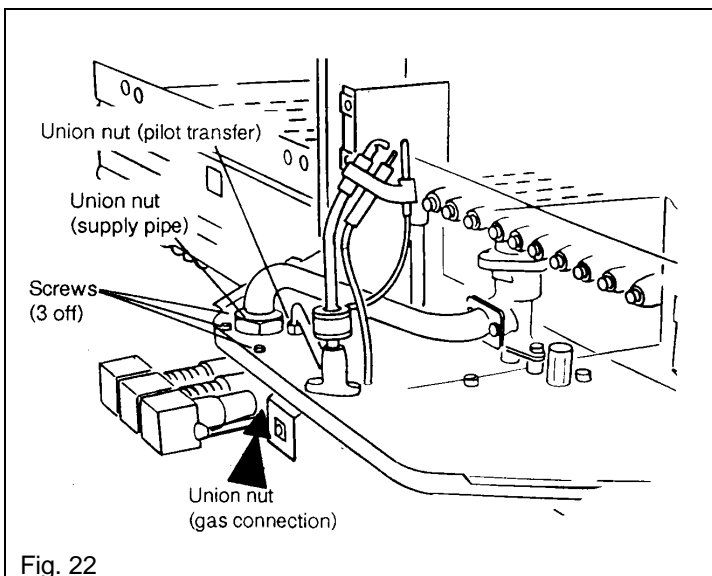
Fig. 22

6.4. PILOT INJECTOR

- a. Gain general access - see 6.2.
- b. Lift up the lint filter, disconnect the union nut and carefully lift up the pilot tube taking care not to lose the pilot injector.
- c. On re-assembly ensure the pilot injector is correctly seated (taper side downwards) and that the lint filter is correctly assembled and located on the union nut.

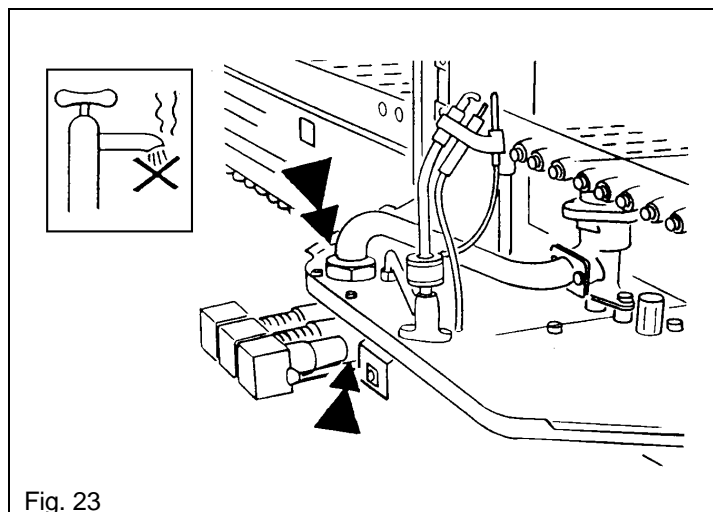
Fig. 23

6.5. FLAME SAFETY DEVICE

- a. Gain general access - see 6.2.
- b. Disengage the electrode lead from the piezo unit.
- c. Release the thermocouple from the back of the flame safety device.
- d. Release the union nuts above and below the flame safety device.
- e. Release the union nut securing the pilot transfer tube to the flame safety device.
- f. Remove the 3 screws securing the flame safety device to the chassis base and carefully withdraw the unit.
- g. Re-assemble in reverse order.

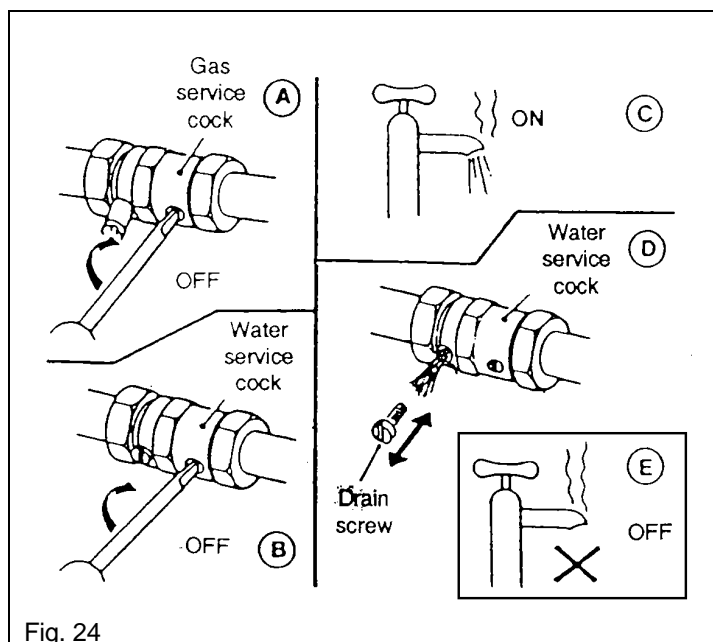
Fig. 24

6.6. TO DRAIN THE APPLIANCE

- a. Ensure that the gas and water service cocks are turned OFF.
- b. Open a hot water outlet.
- c. Have a suitable container to hand. Remove the drain screw from the water service cock and allow the water to drain.

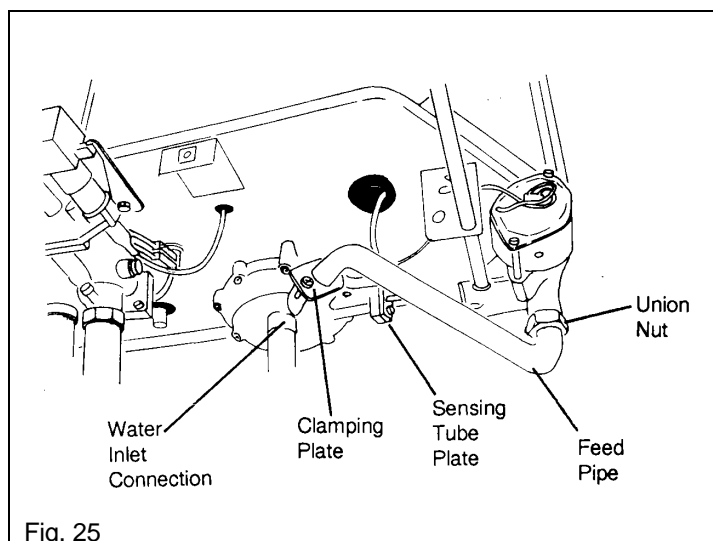
Fig. 25

6.7. WATER GOVERNOR

- a. Gain general access - see 6.2.
- b. Drain the appliance - see 6.6.
- c. Release the inlet water connection and lower the pipework to clear the inlet.
- d. Release the union nut and clamping plate then remove the feed pipe. Replace the 'O' ring if necessary.
- e. Remove the screw and plate securing the sensing tube to the water governor. Replace the 'O' ring.

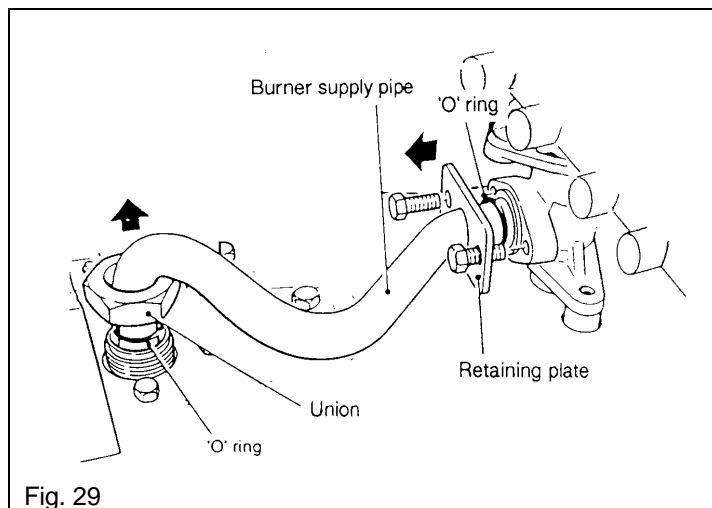
Fig. 29

6.8. AUTOMATIC VALVE AND BURNER MANIFOLD COMPLETE

- a. Gain general access - see 6.2.
- b. Drain the appliance - see 6.6.
- c. Remove the water governor - see 6.7.
- d. Release the union above the flame safety device. Do not lose the 'O' ring.
- e. Release the retaining plate (2 screws) and remove the burner supply pipe. Do not lose the 'O' ring.
- f. Prise the manifold location brackets apart and carefully lift out the complete assembly.

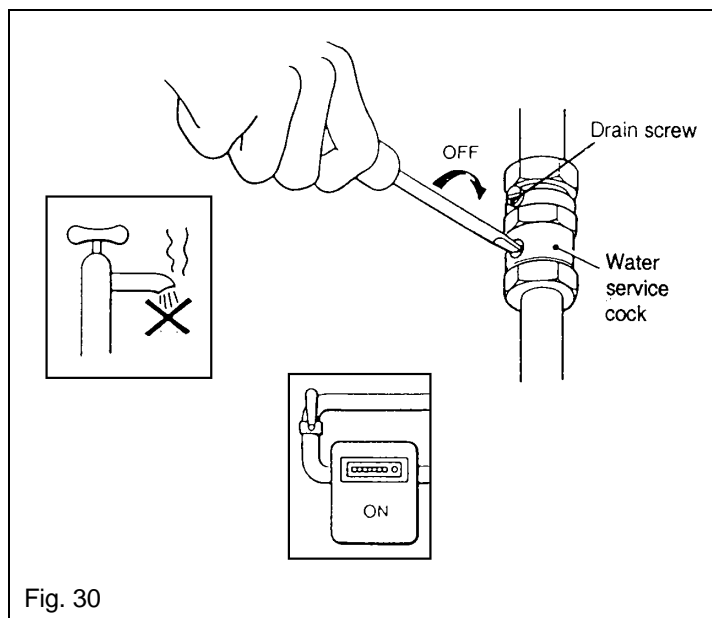
Fig. 30

- g. Re-fit the water governor.
- h. Re-connect the burner supply pipe.
- i. Test for gas soundness as follows:-
 - Ensure the water service cock is in the OFF position, this will ensure that water CANNOT flow and open the automatic valve.
 - Turn ON the gas, purge and light the pilot, this will pressurise the burner supply pipe.
 - Test the burner supply pipe joints for gas soundness using leak detection fluid.
- j. Re-assemble remaining parts and ensure the water service cock is in the ON position.

IMPORTANT: If the automatic valve and burner manifold complete is dismantled, it can only be tested for gas soundness under pressure AFTER blanking off all the injectors.

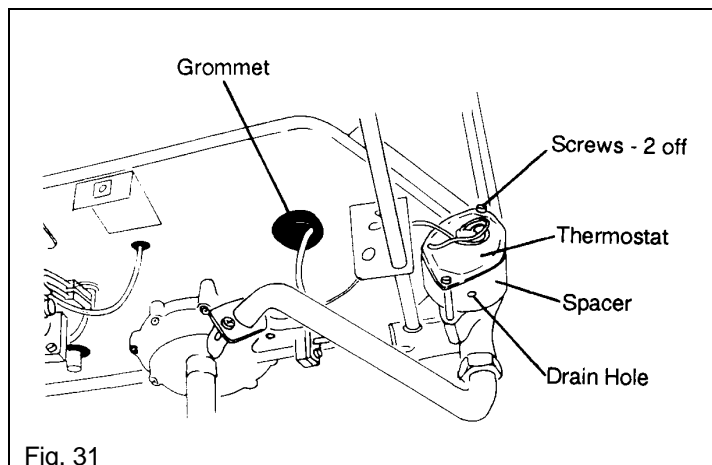
Fig. 31

6.9. THERMOSTAT ASSEMBLY

- a. Gain general access - see 6.2.
- b. Drain the appliance - see 6.6.
- c. Remove the thermostat phial from its pocket. CAUTION: To prevent possible damage to the heating unit, release the split tubing nut with a suitable spanner whilst supporting the phial housing hexagon boss with a second spanner.
- d. Remove the 2 long screws to detach the thermostat assembly and spacer from the throttle body.
- e. Remove the rubber grommet from around the capillary tube in the chassis base then pull the thermostat phial down through the hole.

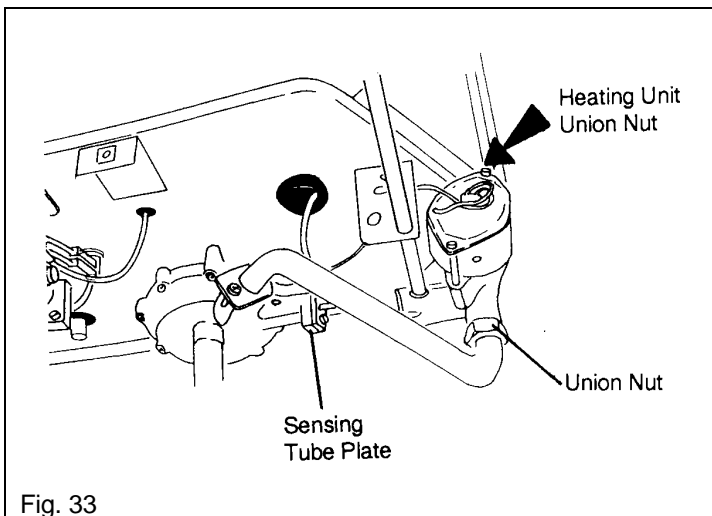
Fig. 33

- f. Feed the thermostat phial through the hole in the chassis base. Re-fit the thermostat assembly and spacer to the throttle body, ensure that the spacer is correctly located between the thermostat flange and the retaining plate and that the drain hole in the spacer is at the bottom when relative to the whole appliance.
- g. Ensure the 'O' ring is correctly seated within the thermostat phial housing, carefully insert the phial taking care not to disturb the 'O' ring. Re-fit the rubber grommet around the capillary tube in the chassis base.

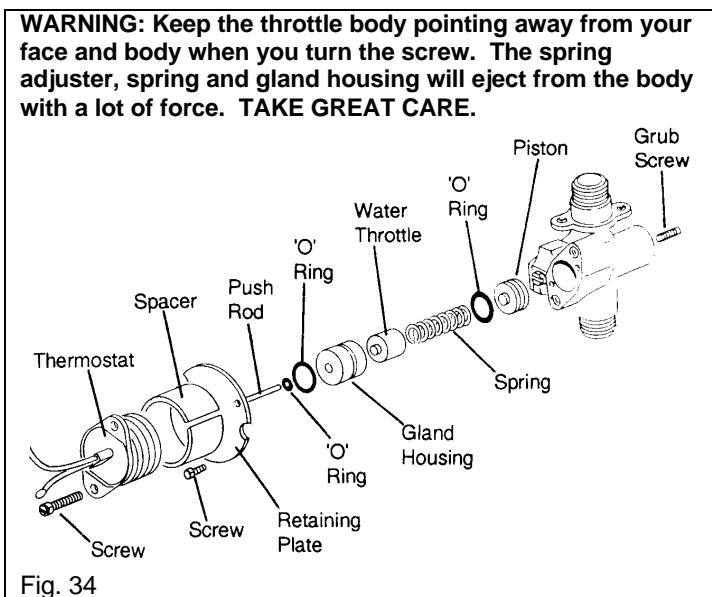
Fig. 34

6.10. THROTTLE ASSEMBLY

- a. Gain general access - see 6.2.
- b. Drain the appliance - see 6.6.
- c. Remove the thermostat assembly - see 6.9.
- d. Release the feed pipe union nut.
- e. Release the screw and plate securing the sensing tube to the water governor.
- f. Release the union nut securing the heating unit to the throttle at the chassis base.
NOTE: When removing the throttle assembly, the temperature selector spindle will disconnect itself from the throttle body. On re-assembly the rod must be positioned before the throttle is secured in place.
- g. Remove the 2 screws securing the throttle to the chassis base then remove the throttle.

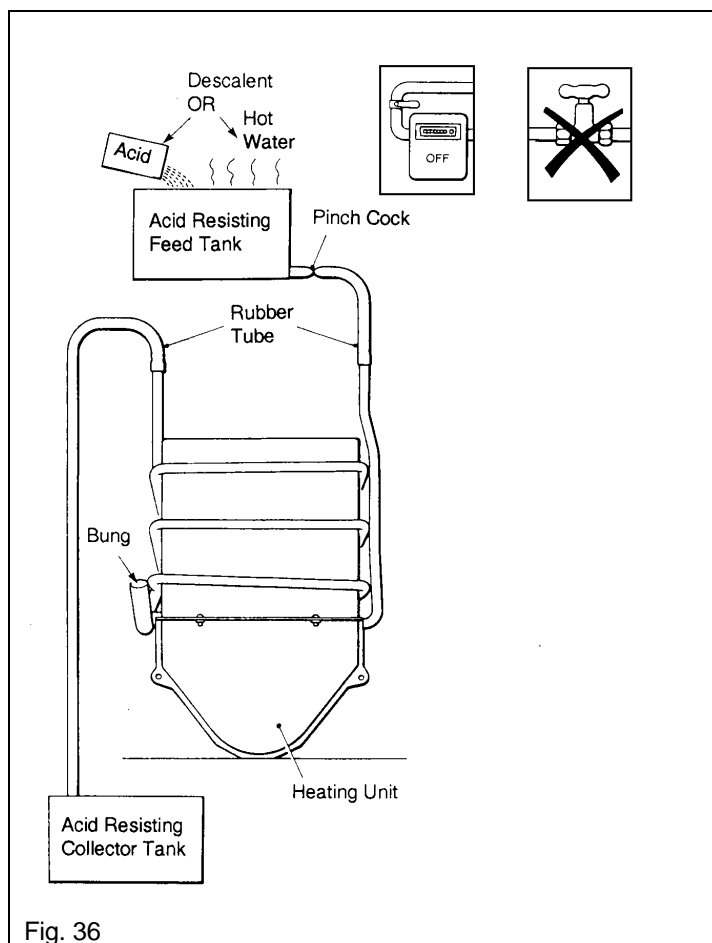
Fig. 36

6.12. DESCALING THE HEATING UNIT

- Gain general access - see 6.2.
- Drain the appliance - see 6.6.
- Remove the heating unit - see 6.11.
- Invert the heating unit on a suitable bench or table.
- Using a suitable bung, close off the thermostat phial pocket.
- Using rubber tube and acid resisting tanks, assemble as shown in fig.36.
- Fill the upper container with a proprietary brand of descalent or a solution of 10 parts water to 1 part hydrochloric acid. The water should preferably be hot, then add ACID to WATER, not water to acid.
- Adjust the pinch cock and allow the fluid to slowly pass through the heating unit into the collecting tank.
- Continue the process until the fluid ceases to bubble. It may be necessary to replenish the solution.
- Disconnect and thoroughly wash out the heating unit with clean water.
